Laboratory and Test-Site Testing of Moisture-Cured Urethanes on Steel in Salt-Rich Environment

December 2000

FHWA-RD-00-156

Federal Highway Administration

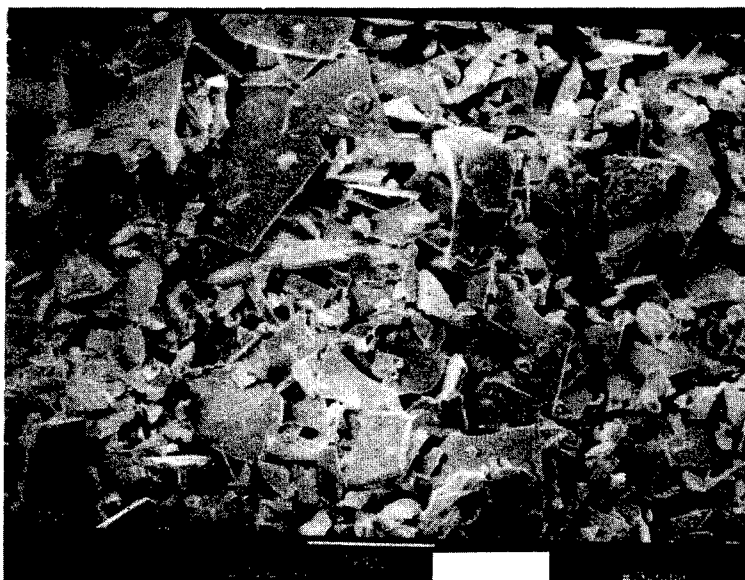
Figure 1. SEM micrograph of natural micaceous iron oxide.

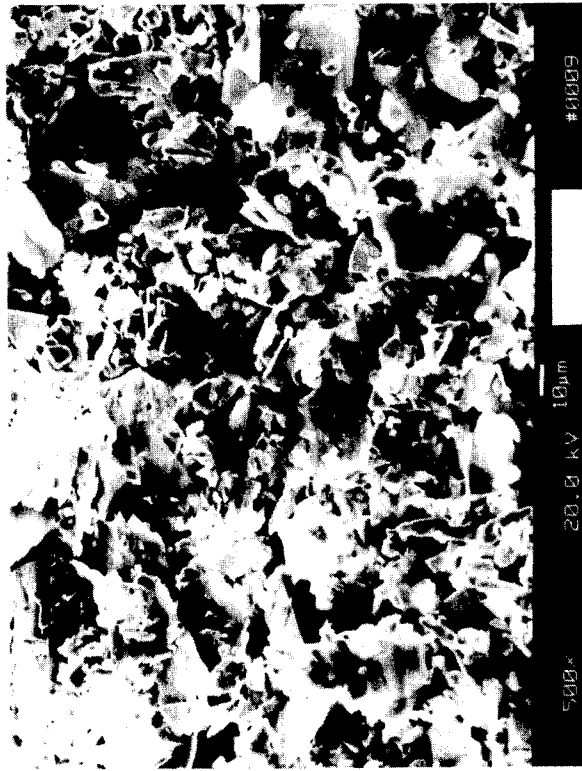
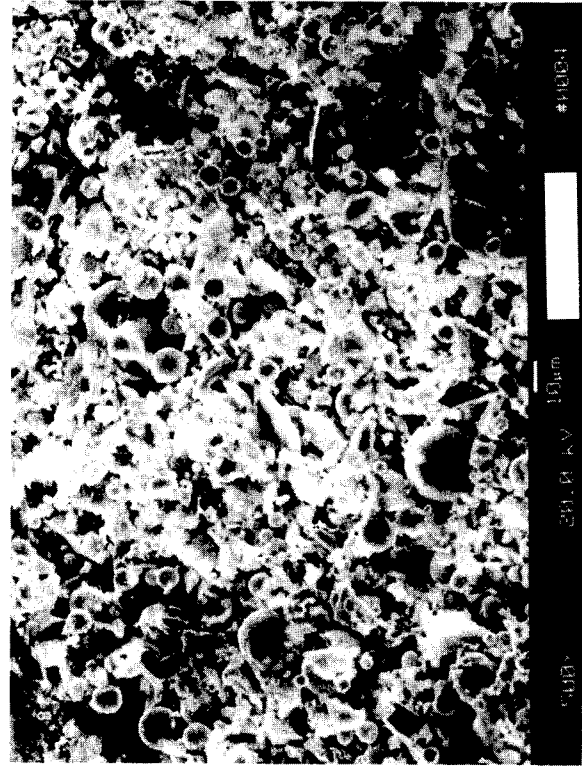
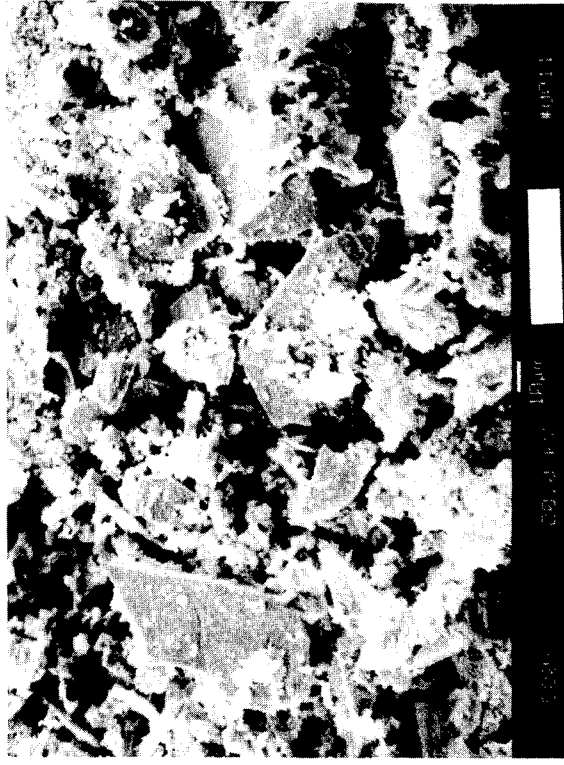
Figure 18. SEM images of pigment in Primers Al, B1, and C1.

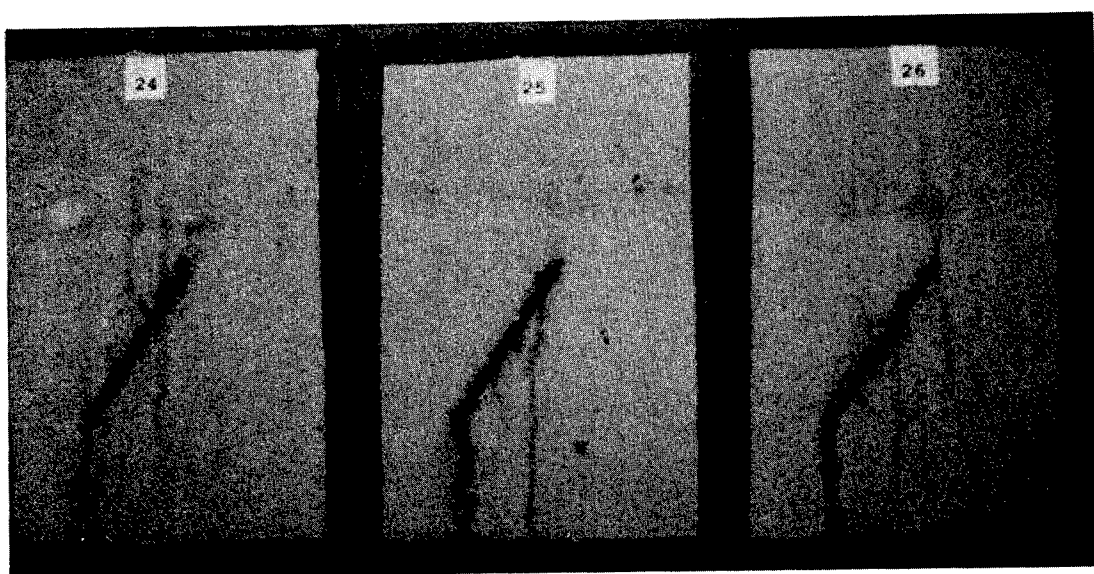
Figure 24. Coating conditions of MC-urethane System A1 over SP 3 (a) and over chloride-doped SP 3 (b) surfaces after 4,000-h laboratory test.

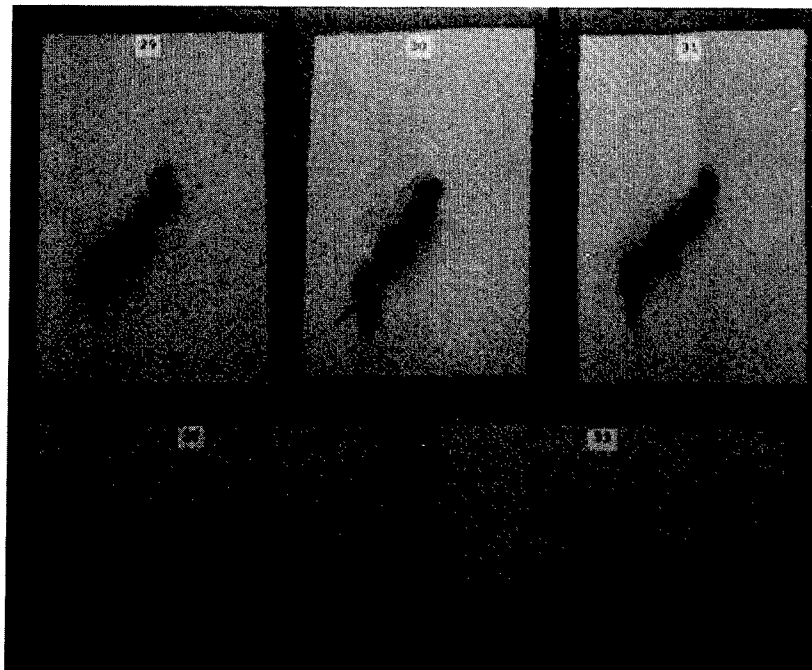
Figure 37. Coating conditions of MC-urethane System A1 over SP 3 (a) and over chloride-doped SP 3 (b) surfaces after 2-yr outdoor exposure.

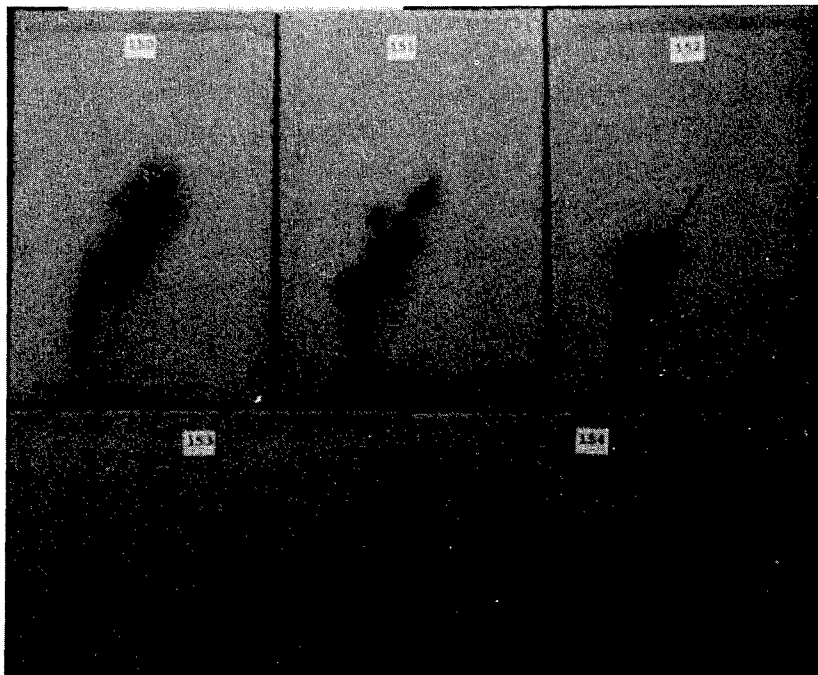
Figure 44. Coating conditions of MC-urethane System C2 over SP 3 (a) and over chloride-doped SP 3 (b) surfaces after 2-yr outdoor exposure.
